Nice Home Example

Today's Date, Inspection Report for: Existing Home at Nice Home Example

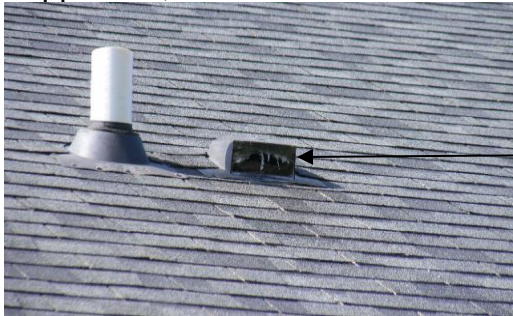
C- The dryer vent has lint at the exhaust (on the rear garage roof). This demonstrates trapped lint, which is a fire hazard and must be cleaned. **2, 5**

Lint at exterior discharge of dryer vent

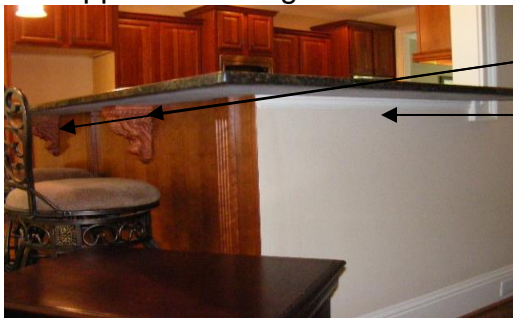
F- Supports for the granite counter at the kitchen are noted only on one side. **2**

Two supports are noted for the rear portion but no support is noted on the left

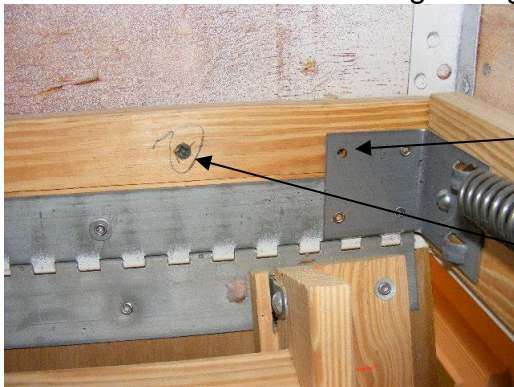
L- The attic pull-down stairs are fastened improperly. Screws are used in lieu of nails (screws have no shear rating – this is a shear load and nails only have shear ratings. Screws that have shear ratings are generally called bolts). **2, 5**

Improper screw

Put nails (16D) in the holes of the brackets that are made for nails

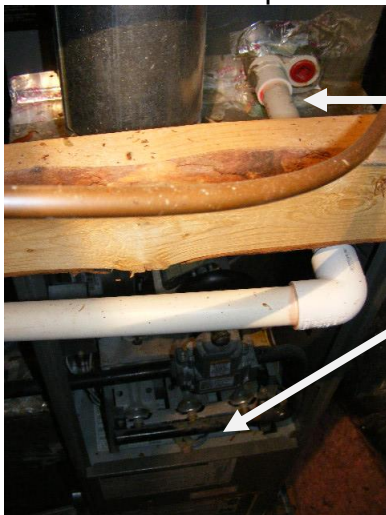
M- Green patina from short freon line insulation is noted at each interior unit. Debris, apparently from original construction, is noted in the attic mounted furnace showing no maintenance. Require a complete HVAC service/repair of all components. **2**

Green patina

Insulation and assorted debris from original construction

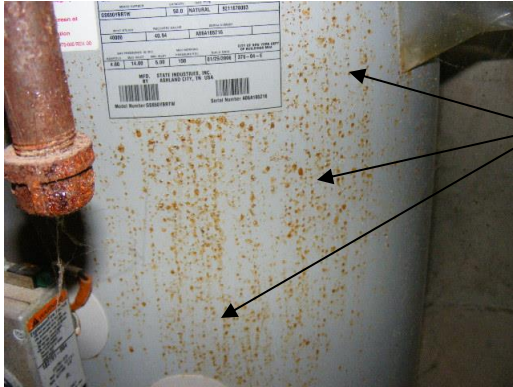
O- The water heater appears to have reached an early maturity as told by heavy rust. **2**

Rust on the outer shell of the water heater

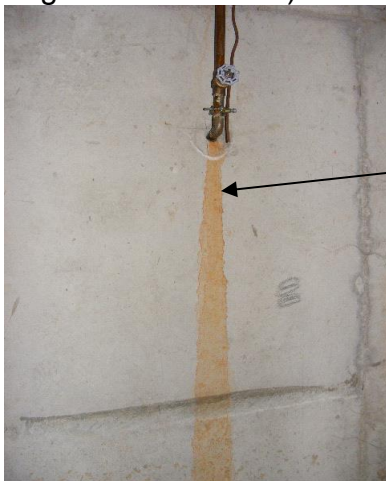
P- An active leak is seen at the main water line pass-through at the foundation and told by the GA clay stain on the concrete wall (the opening appears to have not been sealed from original construction). **2**

GA clay stain below the unsealed water line pass-through shows the active leak

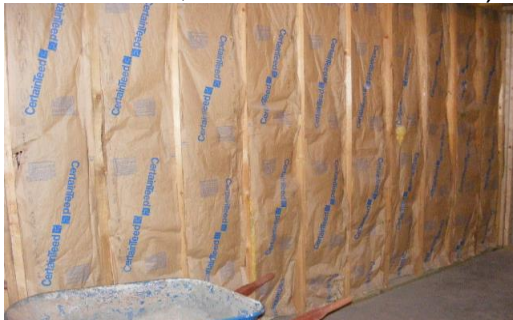
Q- A reminder that vapor barriers on interior walls cause condensation (vapor barriers in a basement in our climate are not a good idea – too much moisture – and if you can not see the moisture, it must be in the wall). *

Example of interior framing in the basement with craft paper
