Needs Work Home

Today's Date, Inspection Report for: Needs Work Home

Sunny, 52 deg. F. Approximate age of the house 45 roof 5

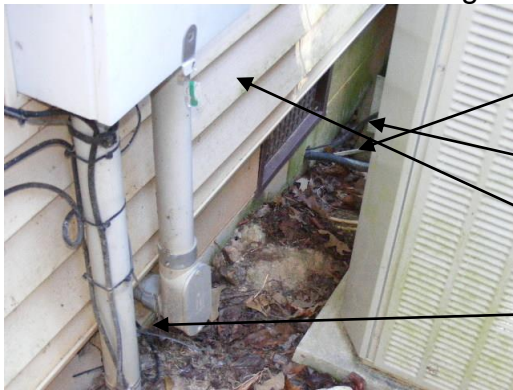
D- The required exterior disconnect is missing at the lone exterior A/C unit. This unit is feed with interior grade cable without protection. Freon line insulation is well worn. The opening for the main electric feed – through the concrete block foundation – has not been sealed. **2**

Unprotected cable

Poor freon line insulation

No disconnect

No seal

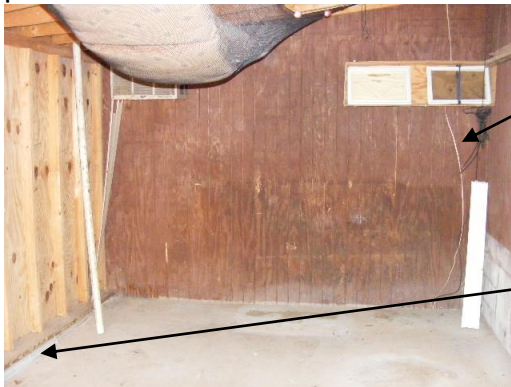
J- Three foundation blocks are missing from the sill support of the rear left lower boat garage. Interior grade cable is noted in the boat garage, poured into the concrete, with no protection. **2**

Interior grade cable without protection

2 of the missing blocks

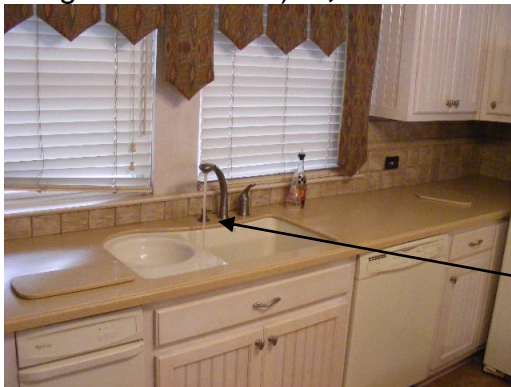
M- A total of 23 feet of counter space is noted in the kitchen (including the island) and only three electric outlets (and one of them is not readily accessible as one must reach past the refrigerator to use it). **2, 5**

No electric outlet is noted

Kitchen sink faucet will not reach the garbage disposal sink

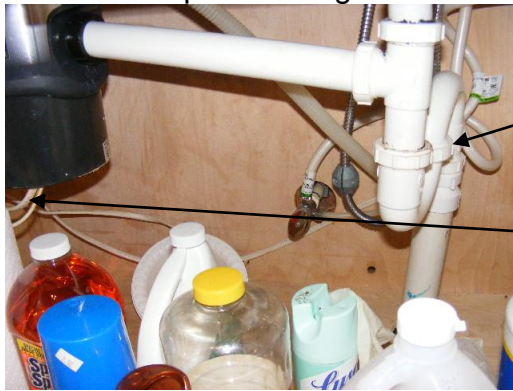
O- Only one proper P-trap/vent is noted under a sink and it is the original sink drain at the $\frac{3}{4}$ bath (1965). Unprotected wiring is noted under the sink and it appears the garbage disposal is used as a pass-through for other wiring. **2**

Improper S-trap

Shared, unprotected wiring

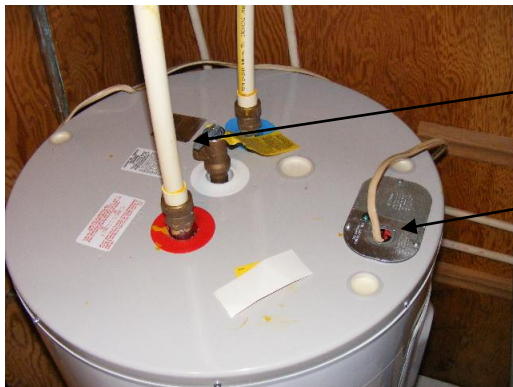
Y- The left side water heater has visible electric connections and no TPR line. **2, 5**

No TPR line

Visible electric

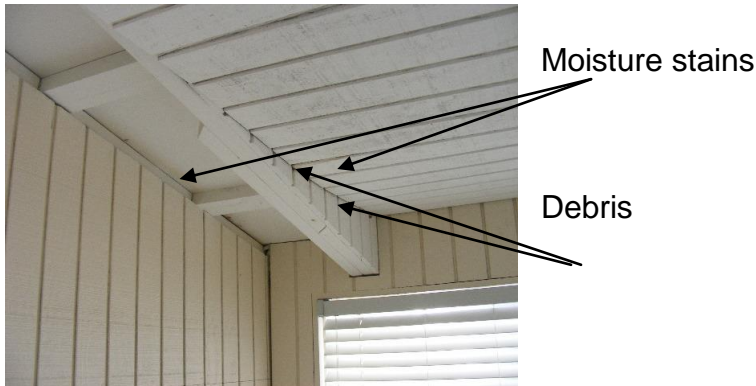
Z- The ceiling at the main level left side room with the sliding glass door appears bowed. The ceiling of the next space to the left (with large fixed windows) has fallen, has moisture stains and debris hanging through (pine straw, etc.) showing an opening and leaks from the exterior. **2**

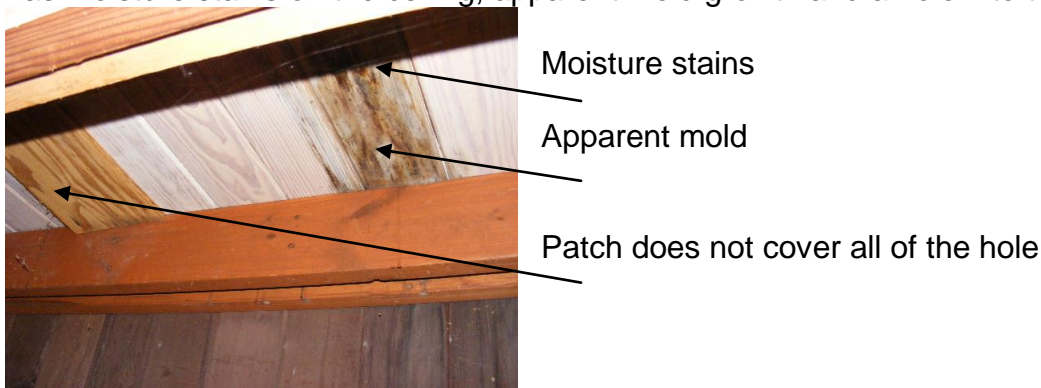
BB- The closet between the ceiling noted in item "Z" and the bathroom noted in item "AA" has moisture stains on the ceiling, apparent mold growth and a hole into the attic. **2, 4**

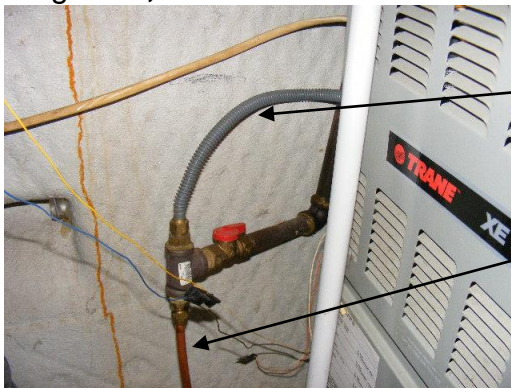
DD- Copper tubing is used improperly for gas distribution at several locations. Only solid carbon steel pipe should be used inside a house for gas distribution. Copper tubing melts in a fire providing a tremendous source of fuel. **2, 5**

EE- No signs of maintenance are noted at the HVAC. The basement furnace is improperly piped with a flexible gas connector. Temperature is below 65 degree F, no A/C test.

LL- Photo of the basement furnace with the flexible connector inside and copper tubing used for gas. **2, 5**

Flexible connector

Improper copper tubing, installed where the drip leg should be

Require a complete HVAC system service/repair of all units. **2**

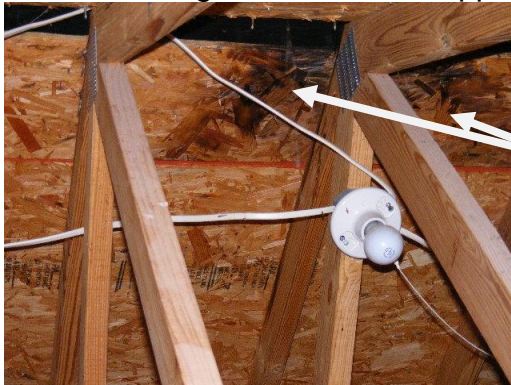
NN- Sheathing stains show an apparent active leak over the master bedroom. **2**

Staining shows moisture flow

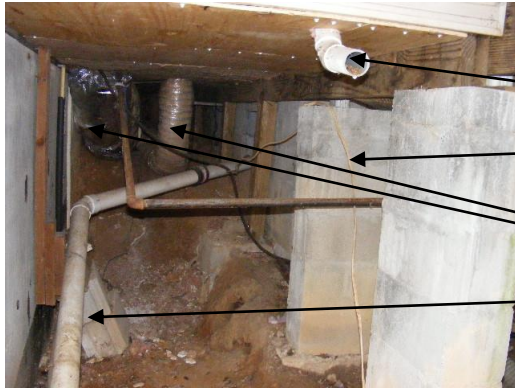
OO- Under the rear right exterior stairs, a pier no longer has bearing and plumbing drains are exposed to the elements and held in place with wood and block shims. Interior quality HVAC ductwork is noted and on the left side. **2**

Improper furnace vent termination has mud wasp nests inside

Shifted pier

Interior quality HVAC on the exterior

Shims for improperly exposed drains

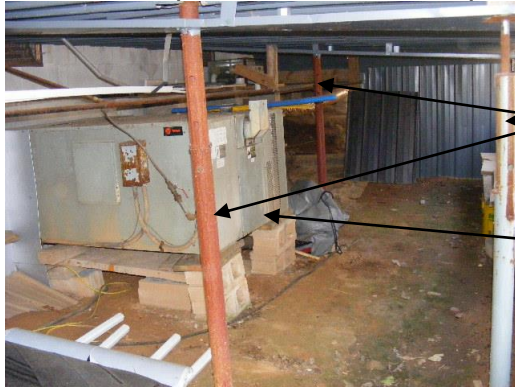
QQ- Temporary steel posts are noted under the rear deck and one is well rusted. The original furnace is seen and exhausts under the rear deck. The furnace is well past its classic life span and makes multiple unusual sounds during operation. **2**

Temporary steel posts

Original furnace

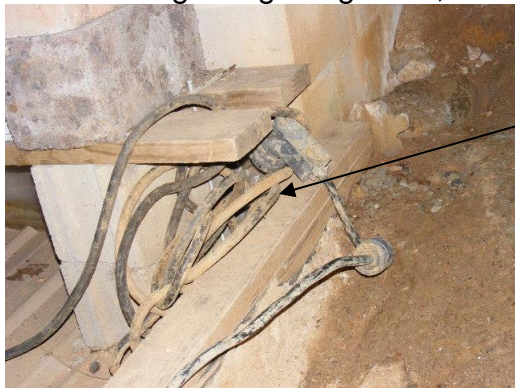
RR- Running along the ground, one can see an assortment of extension cords. **2, 5**

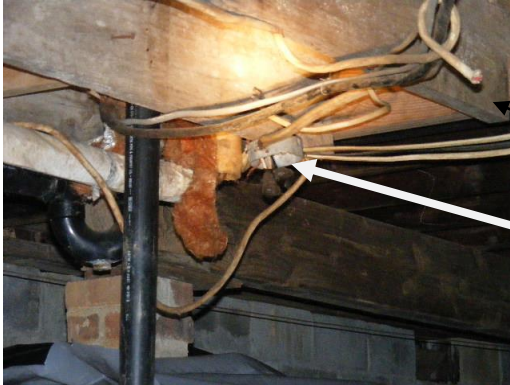
TT- Open wiring is noted in the crawlspace. Behind the wiring, one can see the floor joists are deeper than band joist (the band joist supports multiple floor joists and must be the same size and at least doubled). **2**

Floor joist deeper than band joist

Open electric

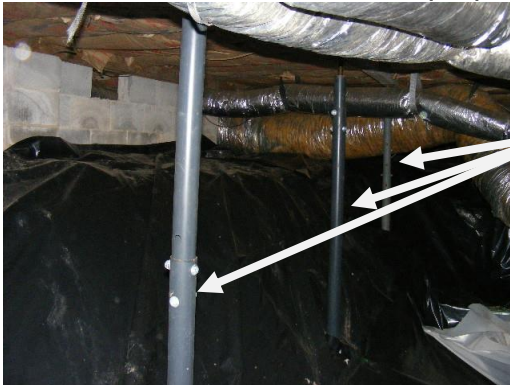
VV- The next photos show three temporary steel posts used in the taller portion of the crawlspace and three proper steel posts used just behind. The improper temporary posts are more recent work and the proper steel posts are original. **2**

Temporary posts

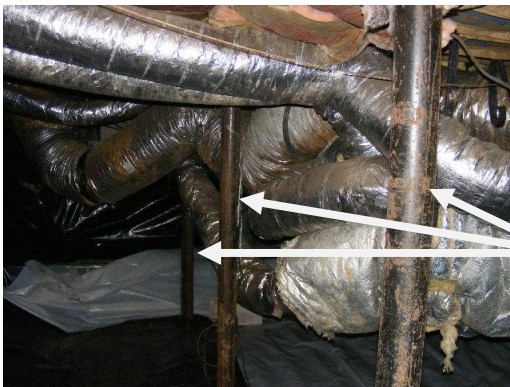
Non-professional "octopus" ductwork

Proper steel posts

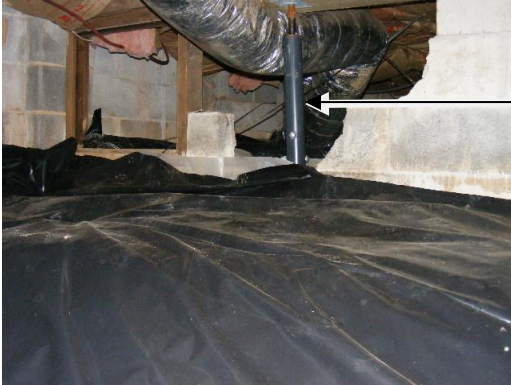
YY- Large openings are noted in the original block foundation. Some have improper repair attempts and others have no repair attempts (same wall). **2**

Repair attempt with over-spanned studs and a temporary steel post

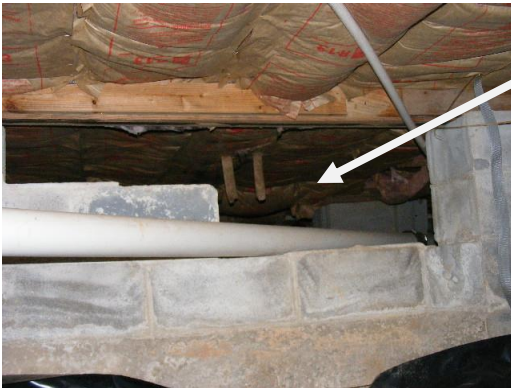
Opening with no repair attempt noted

Insulation is installed backwards also
